Introduction

Scope of Work

New Bedford Harbor Superfund Site

New Bedford, Massachusetts : April 2004 – Present

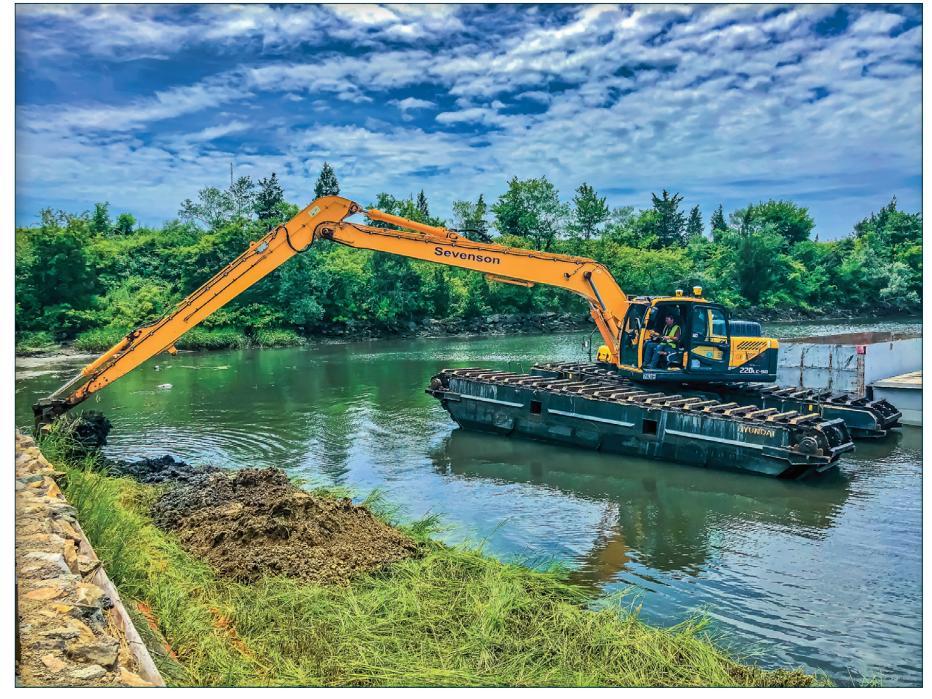
"Contaminated sediment removal in marsh area using a Hyundai 220LC Swamp Hoe"

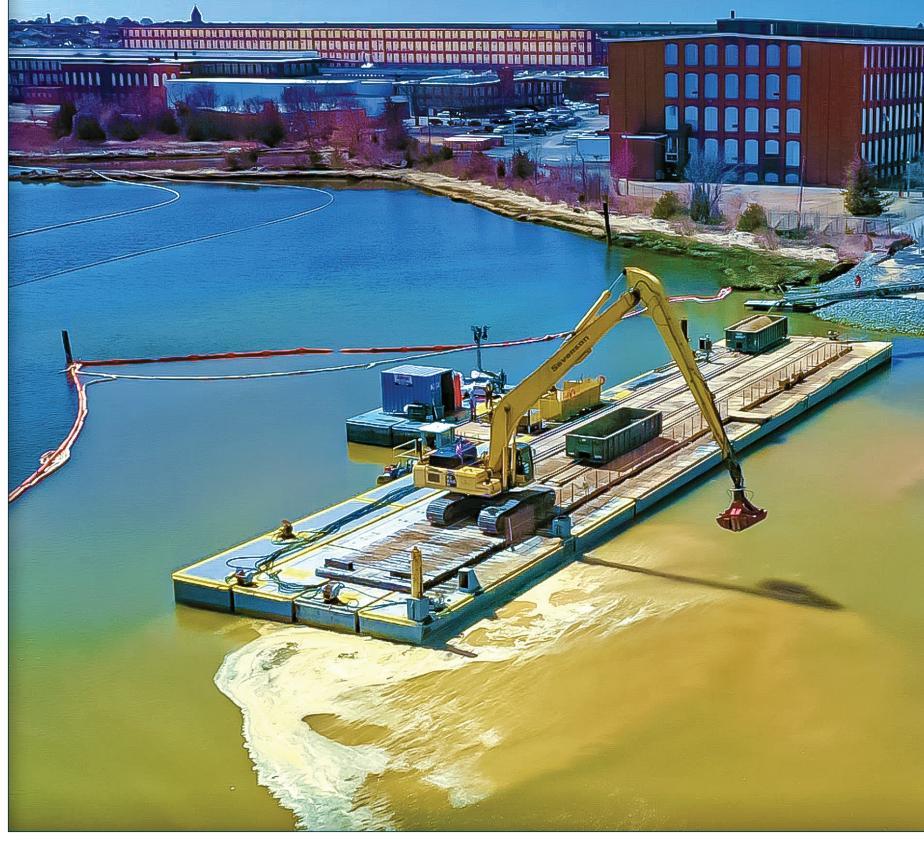
"Multi-layer cap placement near source area using a Komatsu PC450"

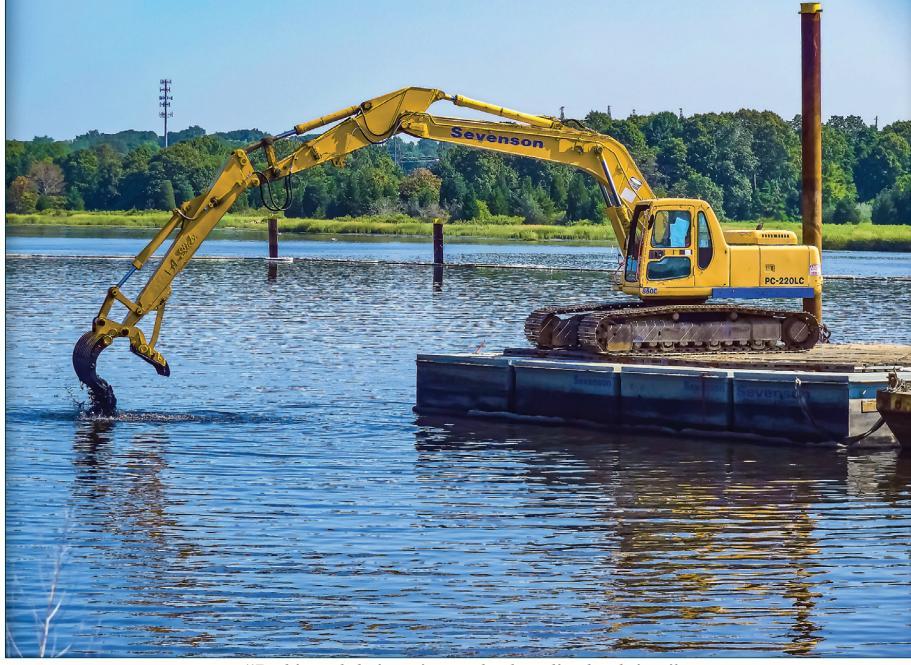
"Raking debris prior to hydraulic dredging"

Debris Removal: Sevenson modified our equipment with a rake attachment, vertical controls and conducted mechanical debris removal activities ahead of dredging to prevent dredge line clogs, equipment damage, and associated schedule impacts. This eliminated driving contaminants deeper into the sediments, mitigated costly downtime for repairs and eliminated rework of dredged areas. To support the dredge system, Sevenson installed a series of single steel sheets. The sheet piles have provided the necessary cabling system tie-offs to allow dredges to operate dredge designated piles areas.

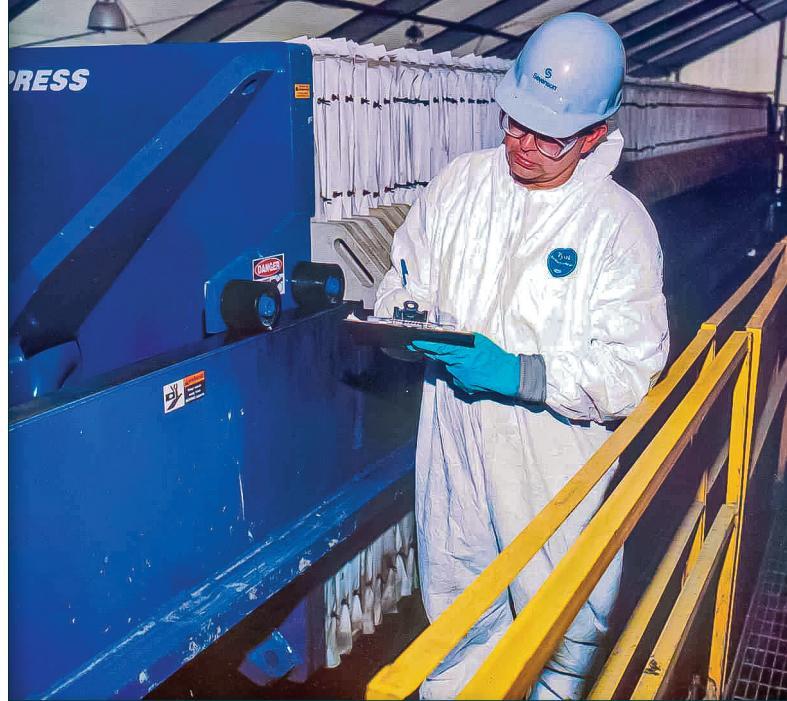
"Filter press operator in D building"

The liquids/solids separation system included eight 160,000-gallon sludge slurry storage tanks, $\pm 10,000$ -lf of 6-12-inch piping and six plate and frame filter presses, each 220 CF capacity. The presses consistently achieved high solids and yield a clean filtrate stream (<50 TSS) that is pumped to the wastewater treatment system. Filter cake was removed from presses and staged for sampling and analysis for contaminants, paint filter and percent solids. Finished piles greater than 50 ppm PCBs were loaded and shipped off-site to a permitted TSCA facility. We improved our process by optimizing polymers, cycle times, and chemical dosages in the non-homogenous sediments to achieve our objectives with minimal materials and bulking and to maximize production. From 10/17-09/19, 194,059 yd³ of sediments were removed.

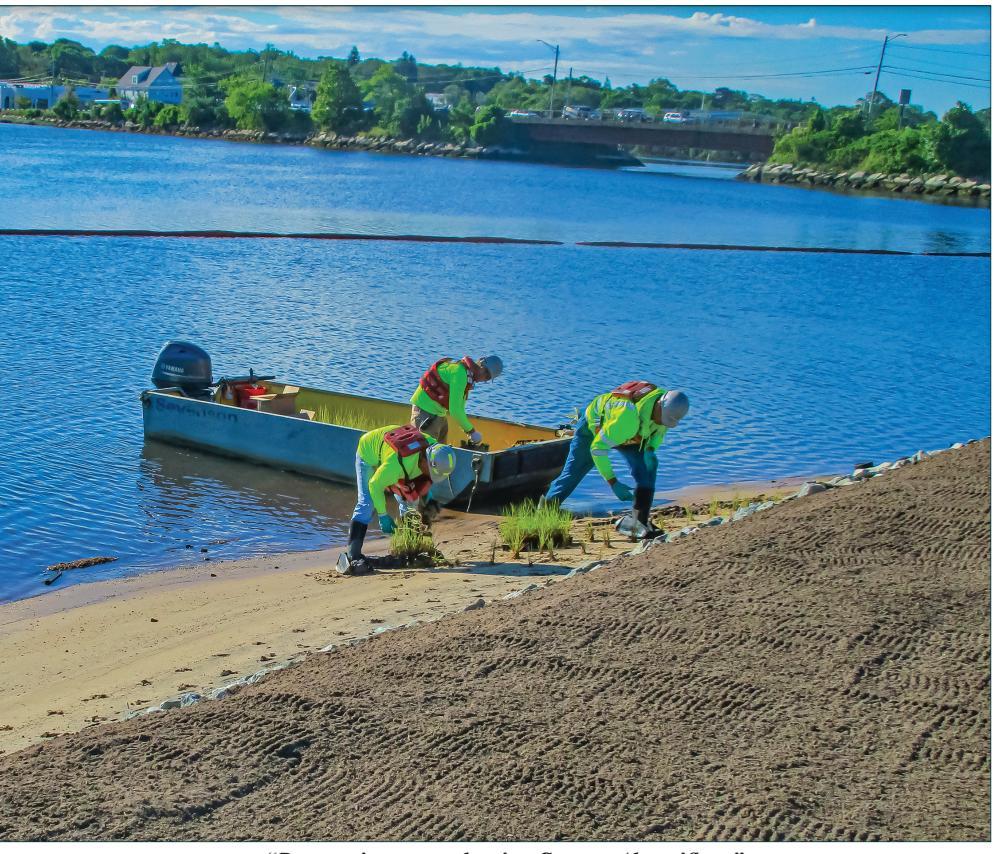
"Restoration crew planting Sparna Alterniflora"

We performed shoreline restoration activities that included plantings and seeding according to three prescribed elevation zones. In the fall of 2015-2016, the EPA and USACE focused the operations on areas planned for mechanical dredging until a replacement contract could be competed and awarded with increased ceiling. During this two-year period Sevenson mechanically dredged approximately 71,000 yd³ in the lower harbor using

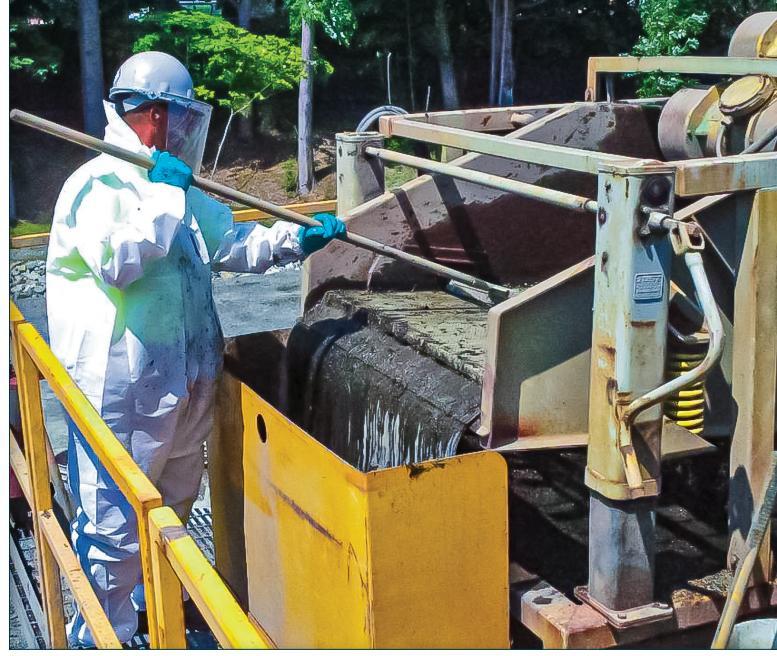
Desanding operation
